EVALUATION OF QUICKBIRD AND IKONOS IMAGERY FOR ASSESSMENT OF HIGH-MOUNTAIN HAZARDS

Christian Huggel, Andreas Kääb and Nadine Salzmann

Glaciology and Geomorphodynamics Group, Department of Geography, University of Zurich;
[chuggel\(at\)geo.unizh.ch](mailto:chuggel@geo.unizh.ch)

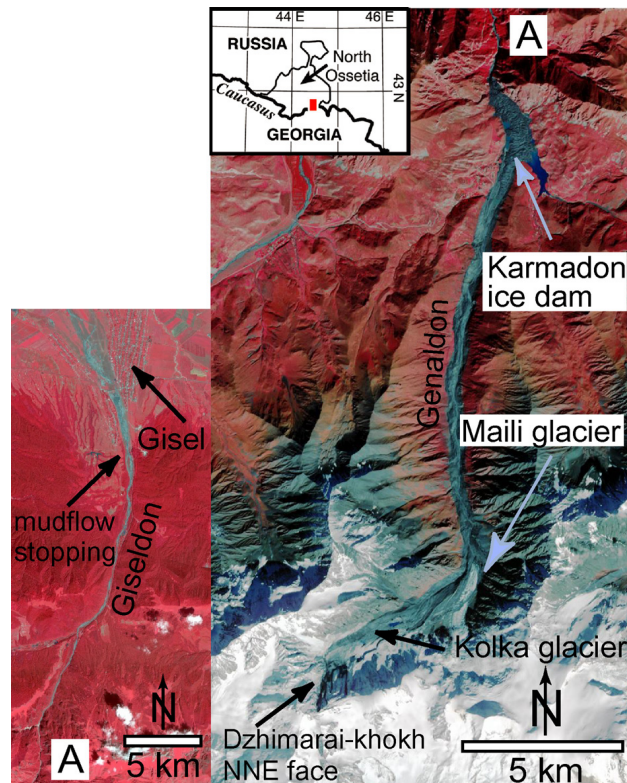
Figure 1: Overview of the 2002 Kolka-Karmadon rock-ice avalanche in the Northern Caucasus starting from the Kazbek massif (Dzhimarai-khokh). The left image shows its continuation to the north (ASTER image from October 6, 2002).

A massive rock-ice avalanche of about $100 \cdot 10^6 \text{ m}^3$ volume took place on the northern slope of the Kazbek massif, North Ossetia, Russian Caucasus, on September 20, 2002 (16,17). The avalanche started as a slope failure, that impacted and almost completely entrained Kolka glacier, travelled down the Genaldon valley for 20 km, was stopped at the entrance of the Karmadon gorge, and was finally succeeded by a distal mudflow which continued for another 15 km (18), Figure 1. In Karmadon, the ice-rock avalanche deposits formed an enormous dam of ca. 2 km length, 0.5-1 km width and 100 m thickness. The event caused the death of approx. 140 people and massive destruction. Lakes which formed at the margin of the dam rapidly grew during the days and weeks after the avalanche and threatened the downstream area (8). An up-to-date ground reference was required for disaster management and hazard analysis. Recent aerial photographs were not available and a special campaign for taking aerial photographs was not feasible due to the political situation (North Caucasus conflict). Physical access to the avalanche starting zone was very difficult. QuickBird imagery could provide the necessary details of the area. The following sections demonstrate QuickBird applications for high-mountain hazards shown with examples from the Caucasus case.

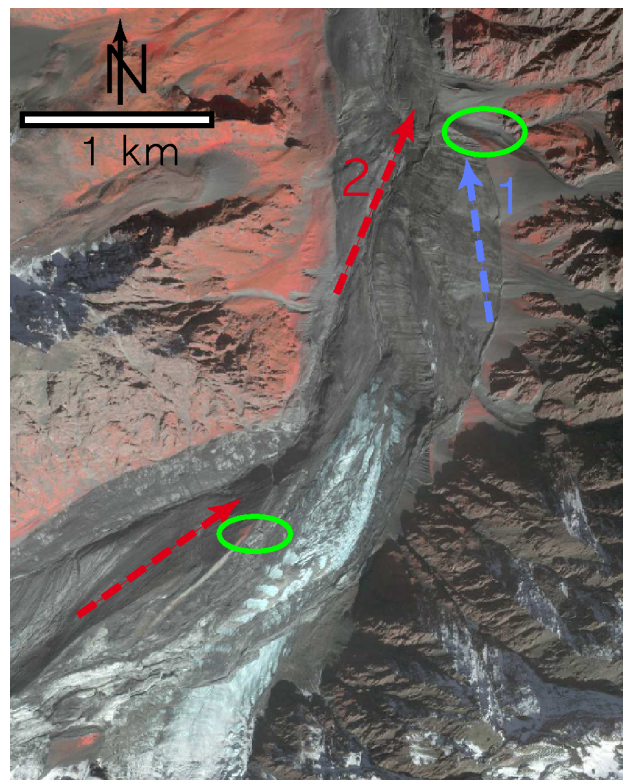
Figure 2: Near-infrared QuickBird image of the superelevation zone of the ice-rock avalanche in the Caucasus. Arrows indicate avalanche flow direction as visible on the image. The blue arrow represents the first more liquid surge, while the red one points to deposits from the second surge. The green circles are evidence of unaffected vegetation (in red), the upper one indicating overjump processes.

In the avalanche track and transition zone various parameters were calculated or estimated on the base of the QuickBird satellite images. Flow depth and width, and a number of cross sections were derived with the aid of a DEM. Avalanche superelevations were measured to calculate the maximum flow velocity (Figure 2). Such parameters were used to reconstruct the processes and for computer models of mass movements. The QuickBird images were highly useful to analyse the flow process, i.e. the detailed direction of the flow, more fluid and solid flow phases, etc. The near-infrared band of QuickBird was used to distinguish between vegetated and non-vegetated areas (high reflectance of vegetation in the near-infrared spectrum). Specific flow processes such as overjumping of the avalanche of ridges could thus be detected. The sharp trim line between areas affected and not affected by the avalanche, which were detectable on the QuickBird images, indicated that the avalanche was a rather liquid flow type without a significant dust part.

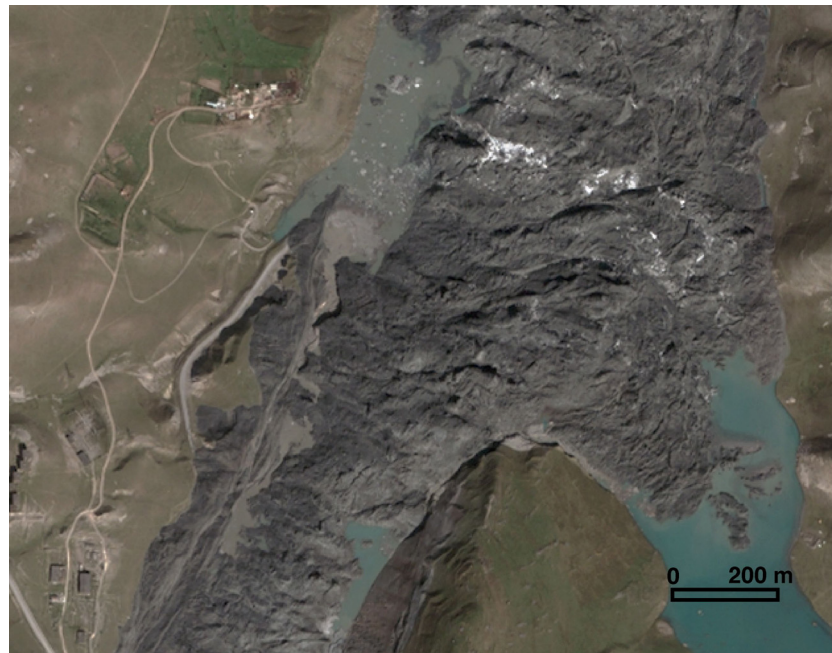
Figure 3: QuickBird image of the upstream part of the ice dam at Karmadon showing well the marginally dammed lakes.

The QuickBird images were also used for studies of the ice dam and the marginal lakes (Figure 3). The areal extension of the ice dam was mapped on the ortho-image. Geodetically measured topographic profiles across the dam in combination with terrain information of pre-avalanche conditions from map-derived DEM yielded the dam depth, and together with dam surface information, volume estimates could be made. Similar calculations of ice dam depth and volume were made using the post-avalanche ASTER DEM and the pre-avalanche DEM yielding maximum ice dam depths of 150 m (15). Errors involved in these calculations can be assessed from a RMSE of 11 m of the ASTER DEM in the ice dam area. It was important to know the ice dam volume in order to reconstruct the avalanche mass volume and to consider the stability of the ice dam. Based on the images, the morphological characteristics of the ice dam were analyzed as well as possible zones of instability indicated, for instance, by dam collapse processes. With simultaneously taken ASTER images, the spatial resolution was a drawback to perform a similar analysis. Drainage channels and the general hydrology of the ice dam were investigated in order to estimate possible related hazards. Likewise, the areas of the different ice-dammed lakes were calculated and stored water volumes estimated. Comparison of QuickBird and ASTER images allowed an assessment of the ice dam development over time (8). Based on these studies, potential water outburst scenarios were defined and impacts on downstream areas anticipated.

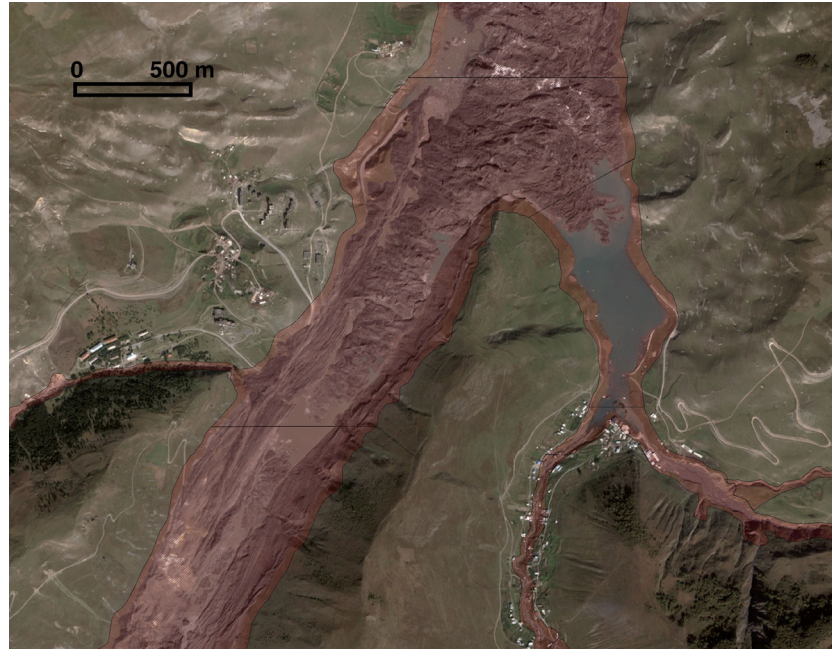
Figure 4: Hazard map for the area of Karmadon/Saniba (North Ossetia), showing the high-danger zone in red, based on hazard modelling and assessment, and using QuickBird satellite imagery mapping.

ger rating (red zone). Delineation of the areal extent of the red zone was based on the 2002 event and on the simulations with computer avalanche and debris flow models (Figure 4). The hazard map is preliminary so far and shows only the high-danger zone. Other hazardous processes such as snow avalanches are not included in this version. For mapping the endangered zones, the satellite images were an excellent means and visualization tool. They can replace topographic maps in the range of 1:10,000.

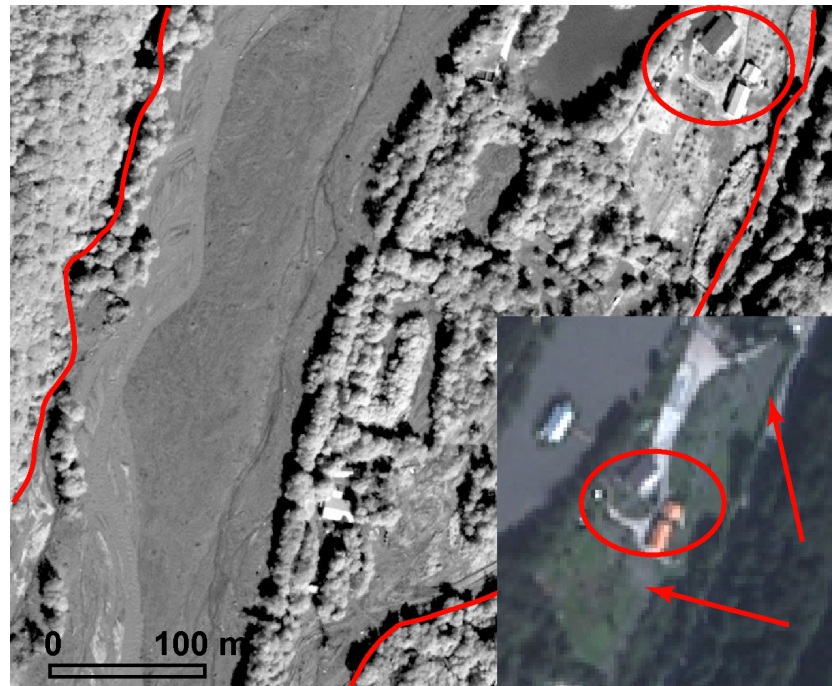
Figure 5: Panchromatic 0.6 m QuickBird satellite image of an area affected by the mudflow in the Giseldon river. The image shows private property affected by the mudflow deposits. The lower right inset is the corresponding multispectral image with inundated areas indicated by arrows. Red circles depict the same buildings in the panchromatic and multispectral images.

Very-high resolution satellites such as IKONOS or QuickBird are currently the only satellite sensors actually suitable for evaluating damages caused by mass movements or floods. The ground resolution is thereby a critical factor. Damage assessment with QuickBird images was possible down to individual buildings (Figure 5). The satellite images were best used to evaluate the number of inundated or destroyed buildings. Precise damage characteristics of single buildings, however, could not even be recognised with QuickBird images. Minor or major traffic routes affected could also be designated.

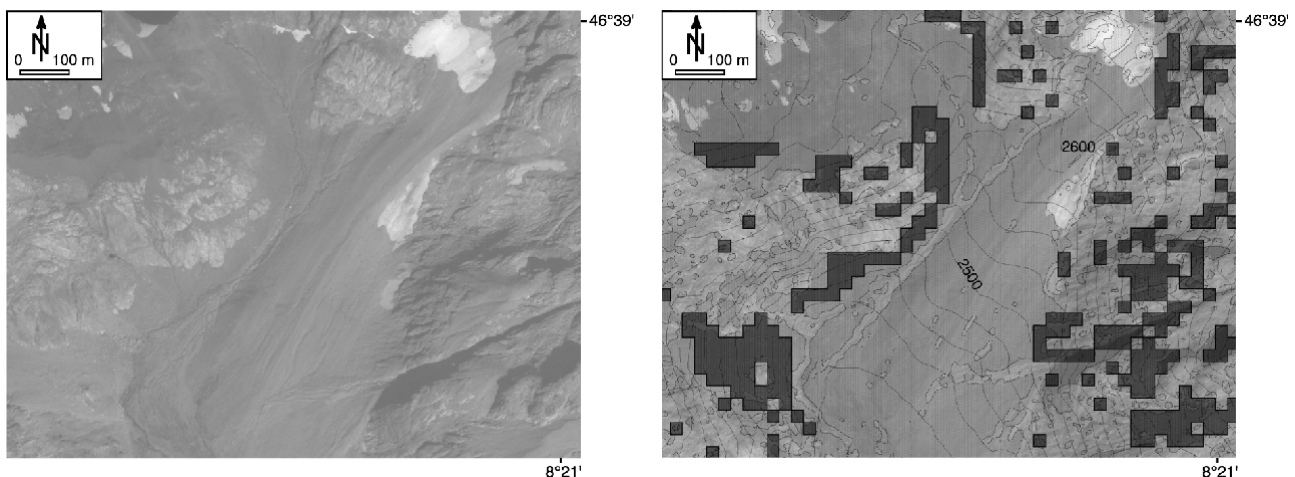
Figure 6: IKONOS panchromatic image of September 17, 2000 with 1 m spatial resolution of a periglacial area in the Grimsel region (Swiss Alps) with mixed presence of large talus slope, debris and bedrock (left). Potential debris flow initiation zones (black) based on the classification of debris reservoirs (grey) and bedrock/sporadic debris (light grey).

The aforementioned studies gave reason to start investigation with the very-high resolution sensor IKONOS. The following methods were developed for automatic detection of potentially unstable debris slopes. An edge detection filter was found to be able to detect the structural uniformity of debris accumulations and to discriminate them from the irregular structure of bedrock (Figure 6). The filter calculates the average of the grey value difference between the central pixel and each of its surrounding neighbours and assigns the value to the central pixel. More uniform areas have smaller grey value differences and are thus assigned lower values. The number of neighbours is defined by a moving window of specified dimensions. An appropriate window size basically depends on the scale of the structure to be detected. Here, best results were obtained by an 11×11 window. The resulting grey value image was then segmented into debris and bedrock according to a threshold value of 47. A 5×5 median filter was finally applied to smooth the classification and avoid small isolated pixels.

For detection of potential debris flow initiation zones, areas with a slope range between 27° and 38° (using the official Swiss 25 m-gridded DEM) were selected from the previously classified debris accumulation areas. The areas thus identified could then be used as an input to a GIS-based model simulating the potential debris flow and delineating areas likely to be affected (10). As outlined in greater detail in (10), the model computes the downstream propagation of the debris flow based on the topography. The travel distance is constrained by a threshold ratio of vertical drop to horizontal run-out distance of 0.19 (i.e. average slope). Several studies have shown that this slope value encompasses debris flow events in the Swiss Alps (23,26) and is thus suitable for a worst-case scenario.
